High Frequency Shock During Random Vibration Testing

Michael Mastovich

Overview

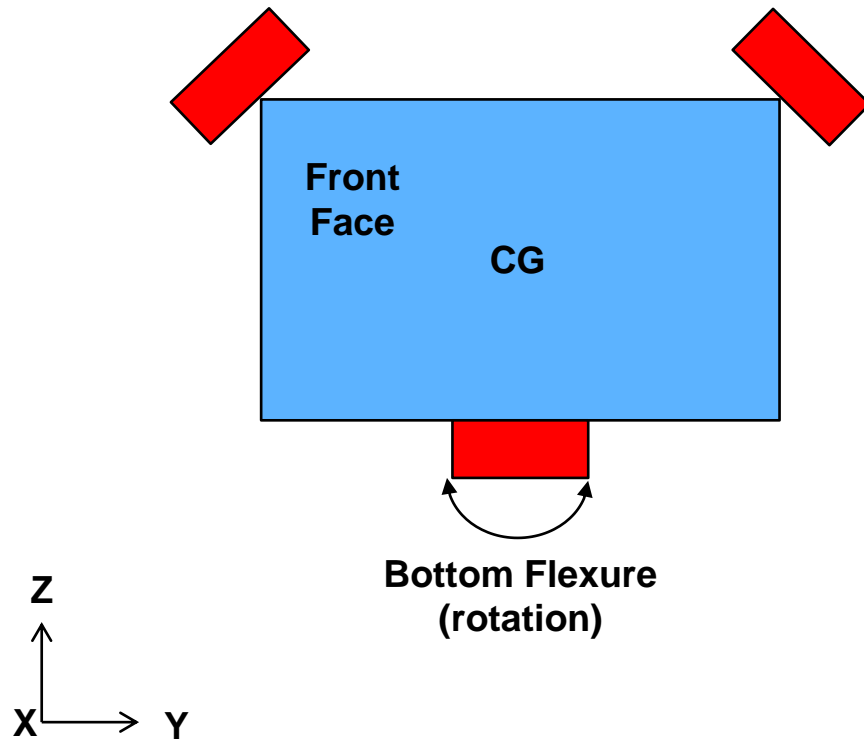
- Experienced high frequency shock during random vibration testing
- Geometry is a ball and gothic arch mount
- Incorrect stiffness of flexures in finite element model led to much higher reaction forces at interface
- What if this was not an audible event? Occurred above 2kHz, therefore outside of normal monitored range

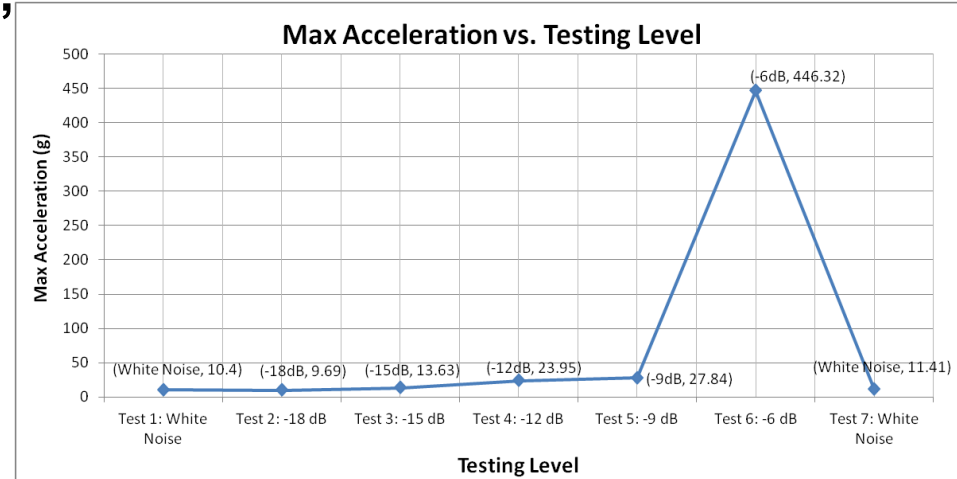
Y-axis Testing Results

- Testing aborted at -6dB: “peening” sound heard acoustically
- Analysis of data shows a max 446.32g shock event at 13kHz originating from flexure (off-axis)
 - Corresponding natural frequency shift during -6 dB test

Testing Level	Natural Frequency (Hz) Ch. 17	Q Factor
Test 1: White Noise	192.5	47.97
Test 2: -18 dB	192.5	51.11
Test 3: -15 dB	192.5	50.14
Test 4: -12 dB	192.5	52.55
Test 5: -9 dB	192.5	44.99
Test 6: -6 dB	190	47.22
Test 7: White Noise	192.5	48.78

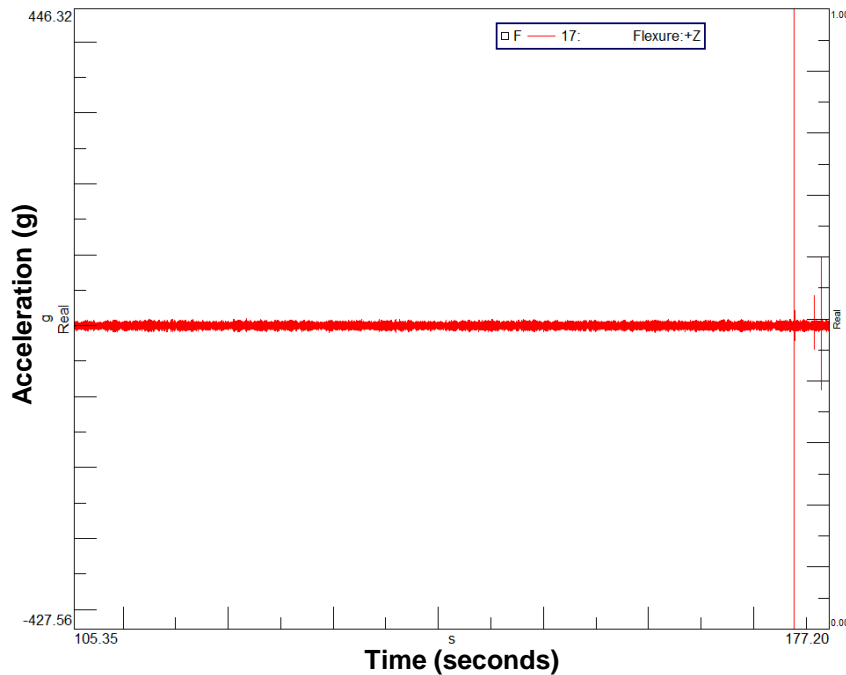
Shock Event

- -6dB Random Input
- Shock origination: Bottom Flexure

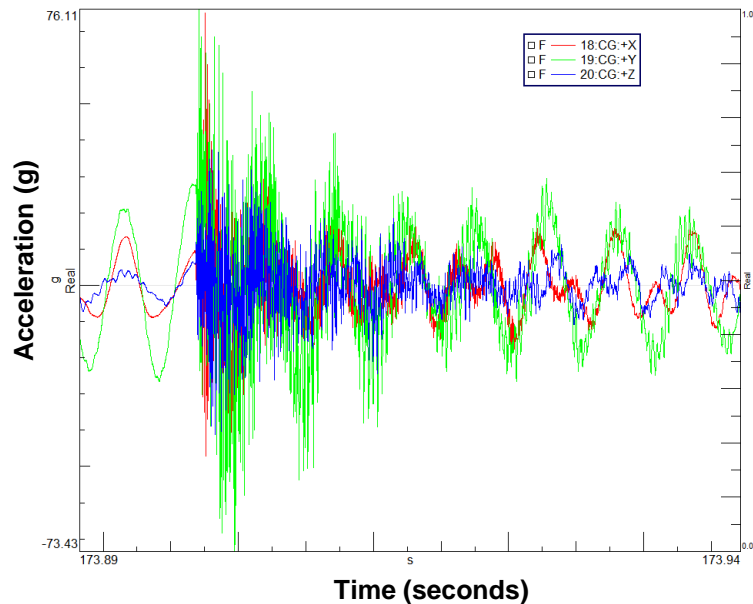
CG Accelerometer

- Ydir Input -6dB Random
- Response at CG accelerometer and Front Face accelerometer

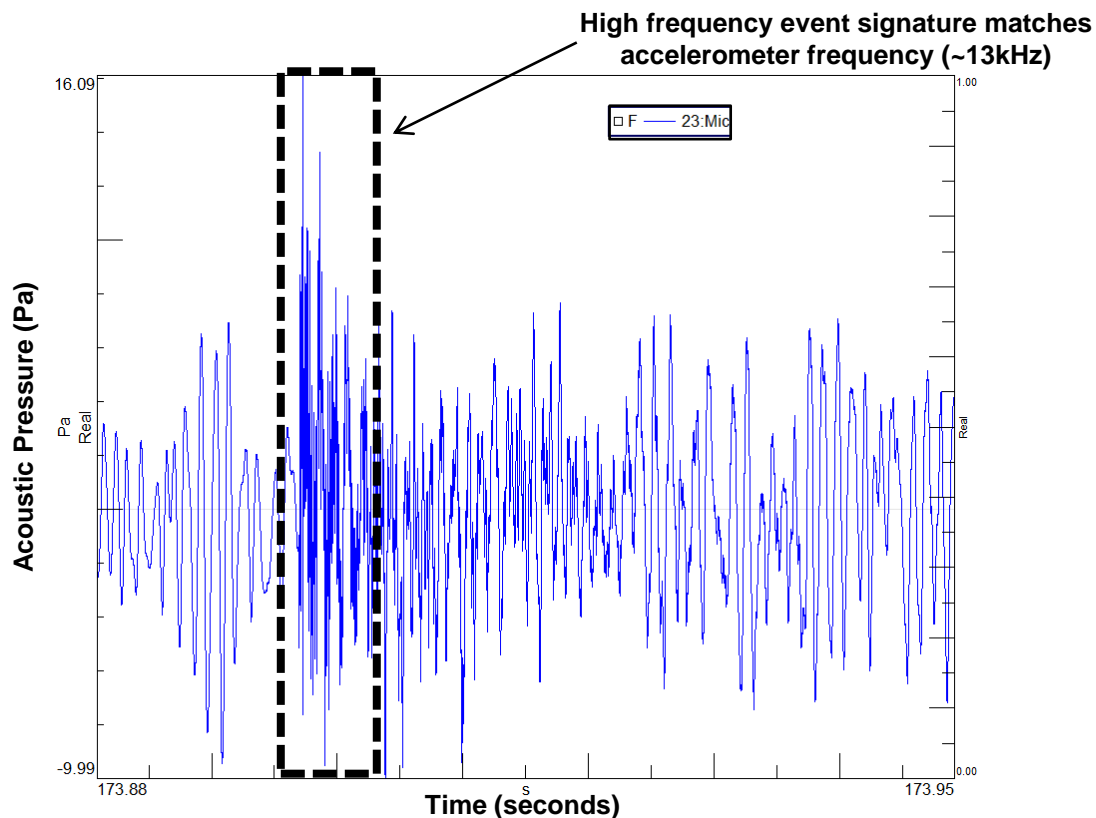
Shock Event Microphone Response

- Input -6dB Random
- Response on microphone normal to bottom flexure (channel 21)

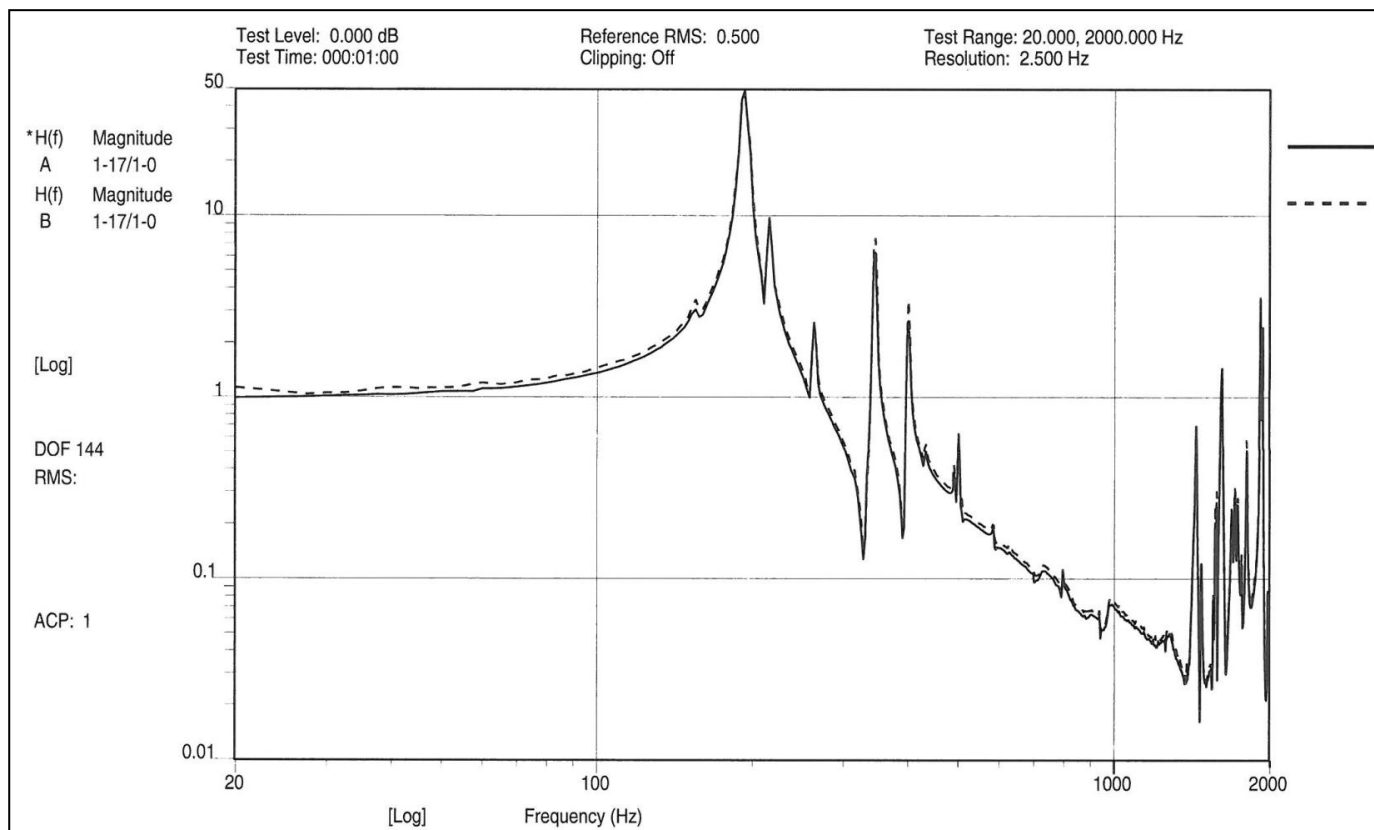
Pre and Post White Noise Comparison

Resonant frequencies and damping are unchanged after the shock event during vibration at -6dB

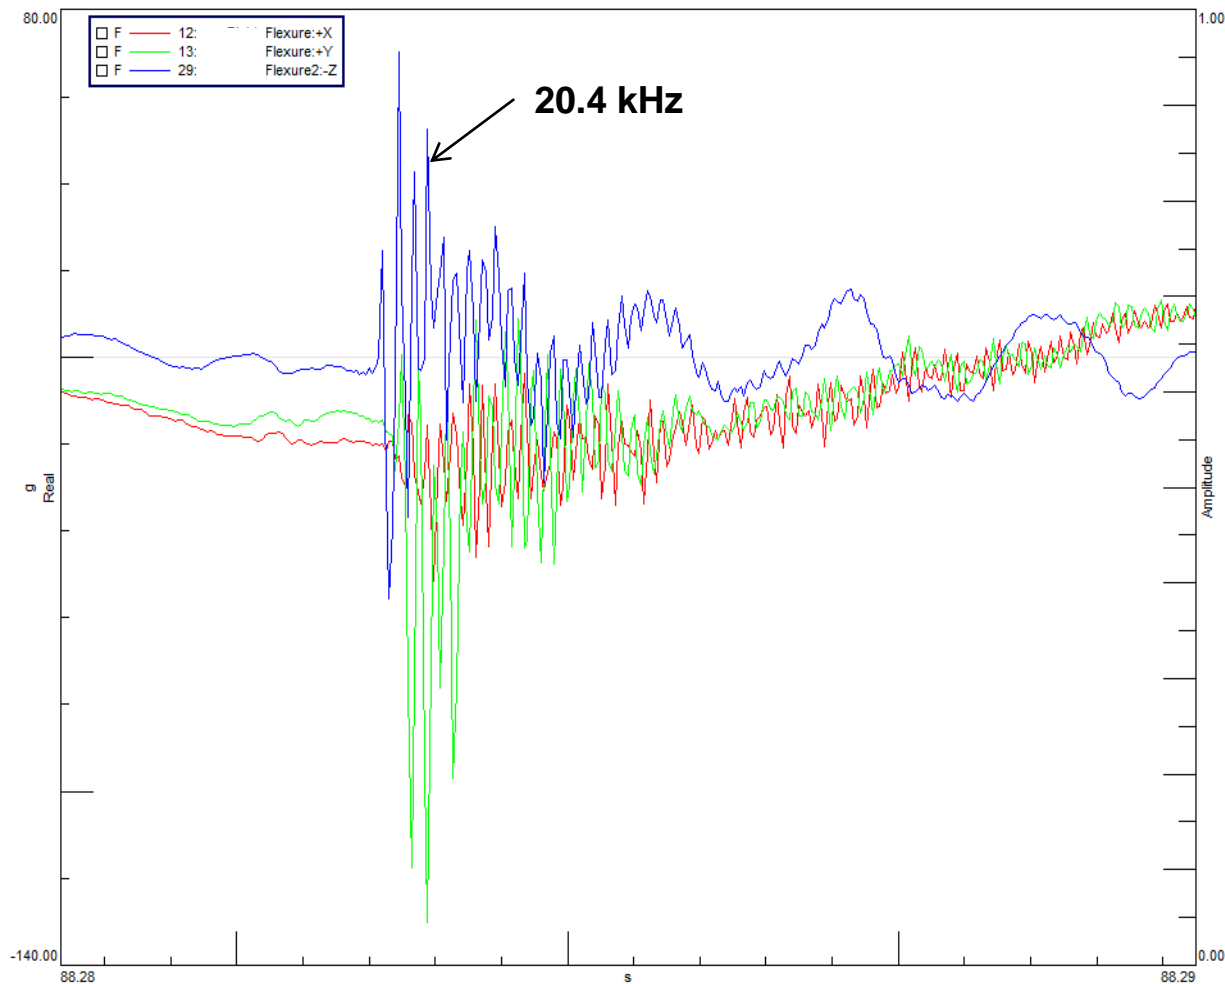
Shock on Flexure

Shock Event

- **System already in final configuration**
- **Not realistic to replace flexures, but needed to fix rotational stiffness**
- **Reduced shock down to acceptable levels by stiffening flexures using Constrained Damping Layer**
